**Corrosion Analysis of 304 Stainless Steel Wire Rope
and Fittings From a NOMAD Buoy Mooring System
After 34-Months Continuous Service
in the Gulf of Mexico**

T. J. LENNOX, JR.

*Physical Metallurgy Branch
Metallurgy Division*

September 1969

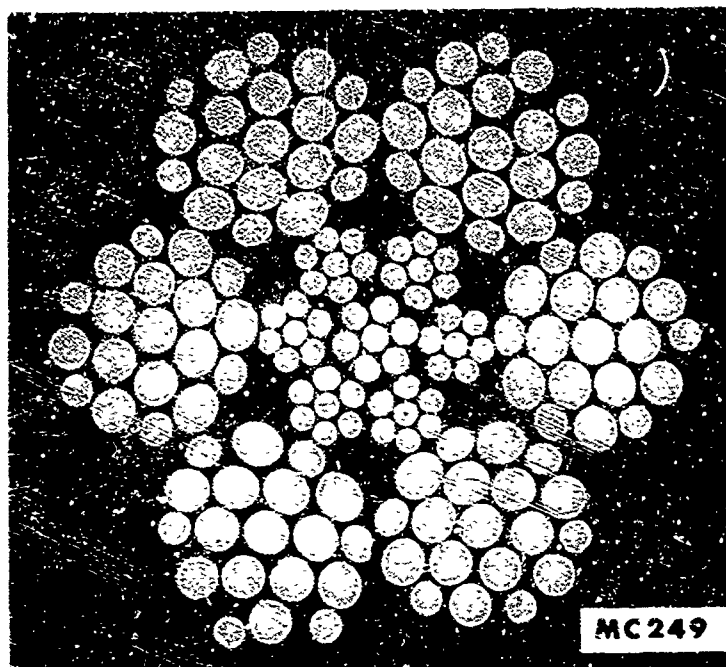
A definite transition was visually apparent between 1005 ft and 1009 ft. This transition was a change from a dark surface film to a heavily rusted condition beneath the neoprene jacket which covered the bottom 250 ft (approximately) of the wire rope. Only slight corrosion was observed just above and 4 in. outside the neoprene jacket. The condition of the wire rope at the rusted end of the transition area has been shown in Fig. 2.

Fig. 2 - 304 stainless steel wire rope after 34-months continuous immersion as part of a Nomad buoy mooring system, showing the moderate-to-severe corrosion at a distance of 1006 ft-7 in. to 1008 ft-7 in. from the top of the wire rope (rusted end of transition - under neoprene jacket).
